# Rocky Flats Environmental Technology Site

# RECONNAISSANCE LEVEL CHARACTERIZATION REPORT (RLCR)

**BUILDINGS 562, 563 AND 564**

**559 CLUSTER CLOSURE PROJECT**

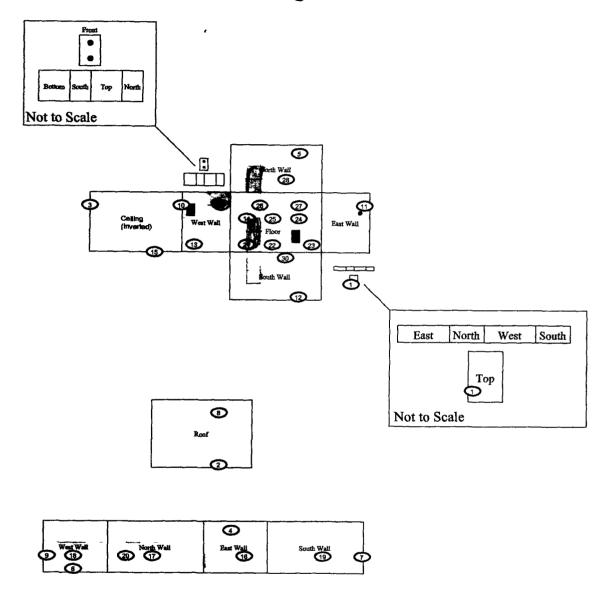
## Building 562

Survey Area A Survey Unit 562-A-001 Type 1
Building 562
Survey Unit Description Interior & Exterior
Total Area 290 sq m Total Floor Area 32 sq m

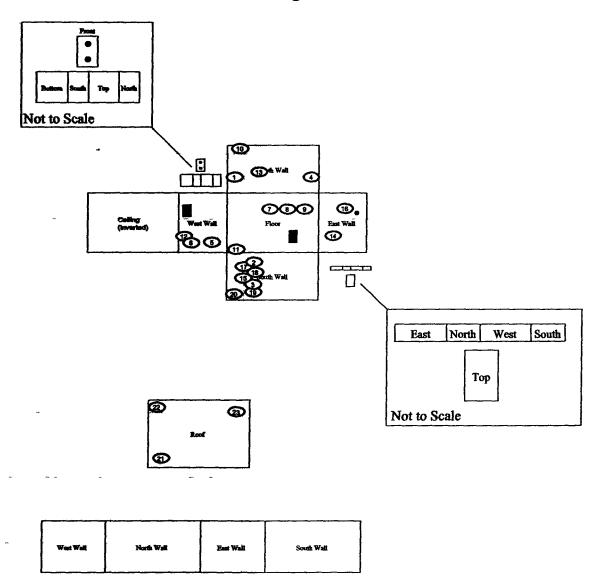
## **Building 562**

562-A-001

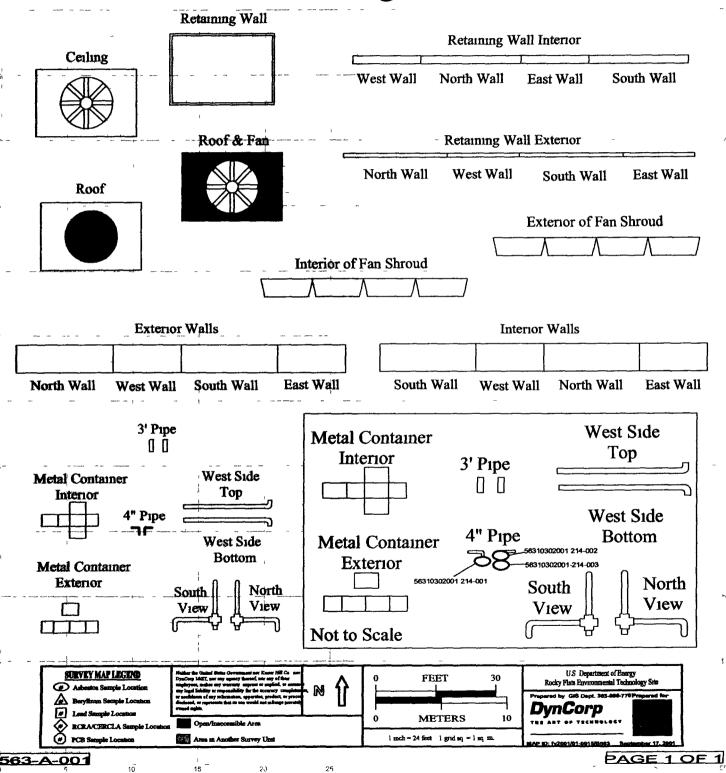
# 563 Cooling Tower

Total Floor Area 80 sq m

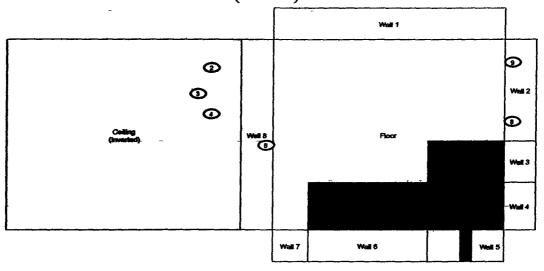
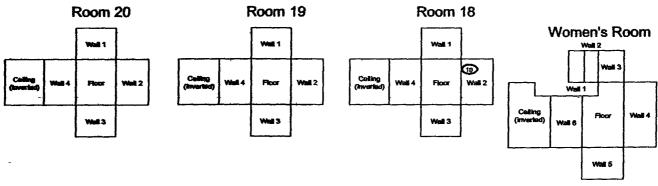
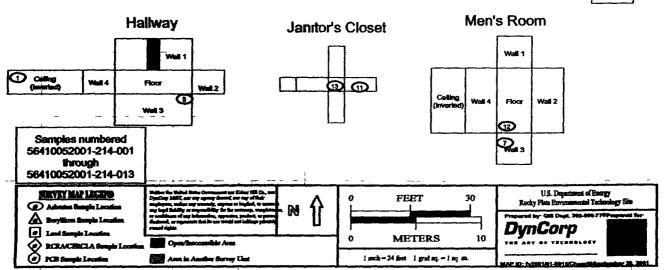
# Building 564 (Interior)

Survey Area: A Survey Building: 564
Survey Unit Description Interior Total Area. 1460 sq m.

Survey Unit: 564-A-001

Total Floor Area 259 sq m

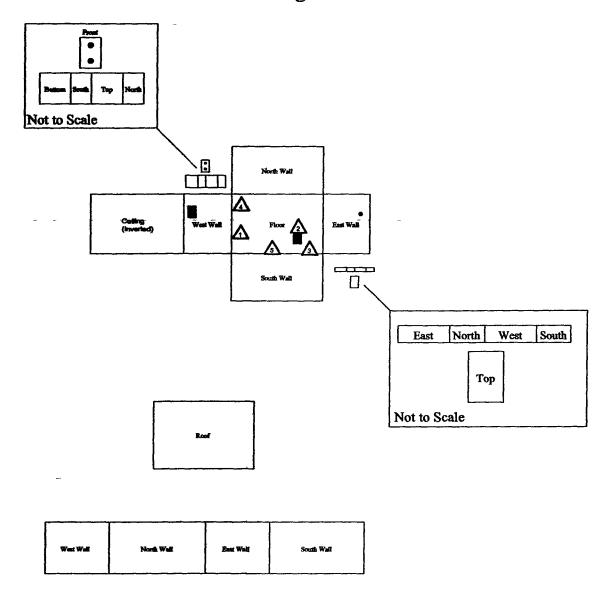
## **Building 562**

Total Floor Area 32 sq. m

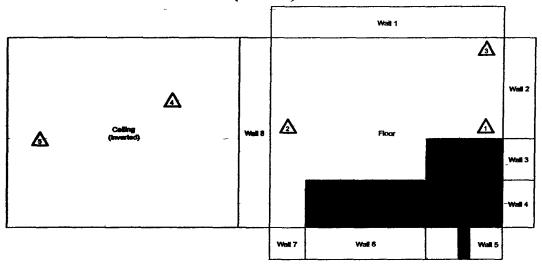
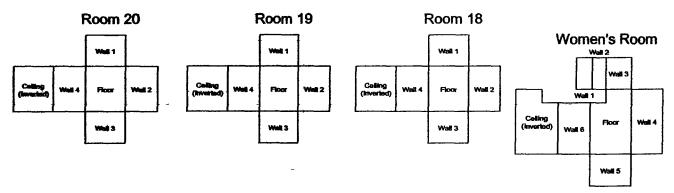
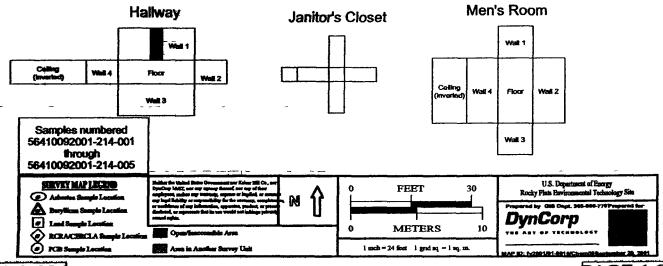
# Building 564 (Interior)

**Survey Unit: 564-A-001**

Classification 3

Total Floor Area 259 sq m
